**Flood Control Project Maintenance
Levee Inspections**

Maintenance Issue Types Only, Levee Inspection Report By Mile - Spring 2015

Reclamation District No. 2063 Crows Landing

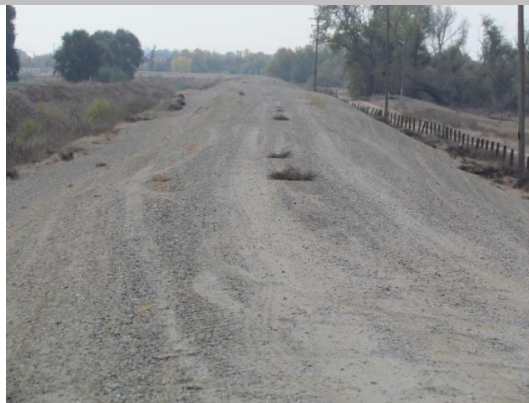
Photo 1 of 1 : SP_2015_RD2063_112_3_20150309_00001.jpg

| Item | Vegetation | | | 37.478550 ° | 37.471548 ° |

Looking south at typical view of waterside and landside slopes.

| Remove the wild growth other than native grasses from the levee slopes. | | | | | |

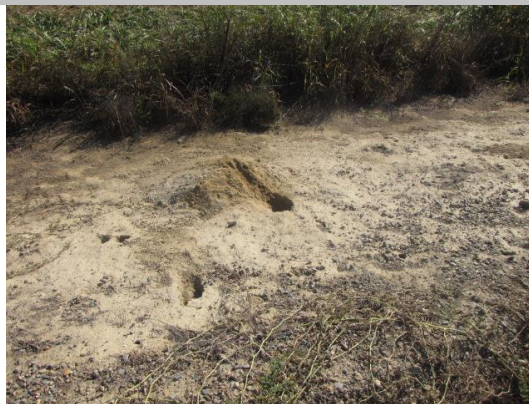
Photo 1 of 1 : SP_2015_RD2063_112_11_20150309_00004.jpg

| No rodents visible, but rodent burrows visible; need to backfill and compact or grout burrows. | | | | | |

Looking east at squirrel holes on landside slope.

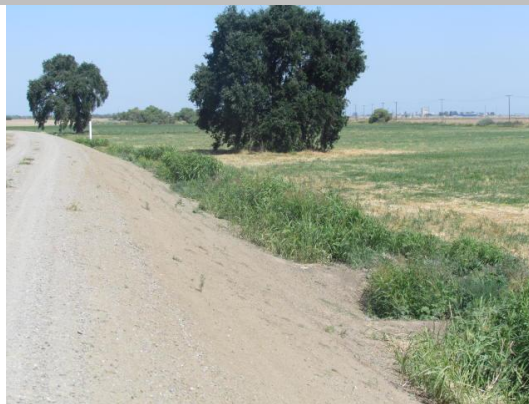
Photo 1 of 1 : SP_2015_RD2063_112_38_20150514_00030.jpg

| Inspector Comments: Control Johnson grass at landward toe. | | | | | |

Looking south at vegetation at landward toe.

| Remove the wild growth other than native grasses from the levee slopes. | | | | | |

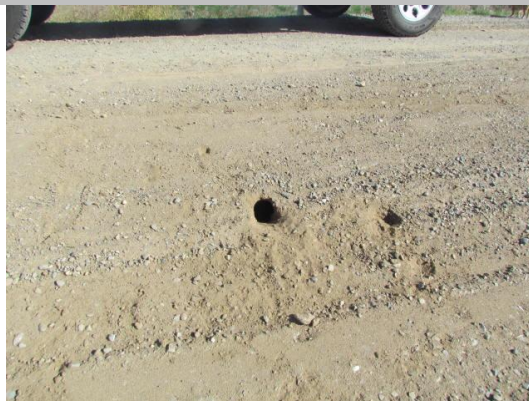
Photo 1 of 1 : SP_2015_RD2063_112_53_20150309_00012.jpg

Looking north at typical view of rodent holes on waterward slope.

| Exterminate rodents and backfill and compact or grout burrows. | | | | | |

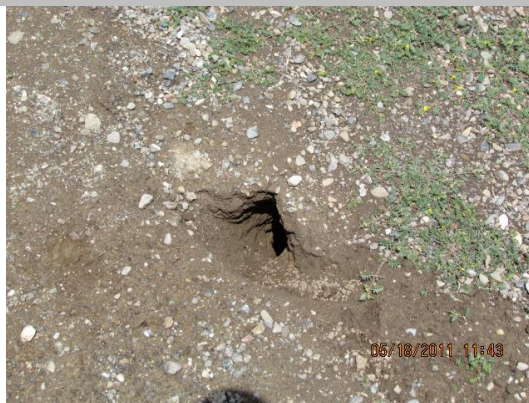
Photo 1 of 1 : SP_2015_RD2063_112_29_20150309_00008.jpg

| No rodents visible, but rodent burrows visible; need to backfill and compact or grout burrows. | | | | | |

Looking at typical view of a squirrel hole on landside shoulder.

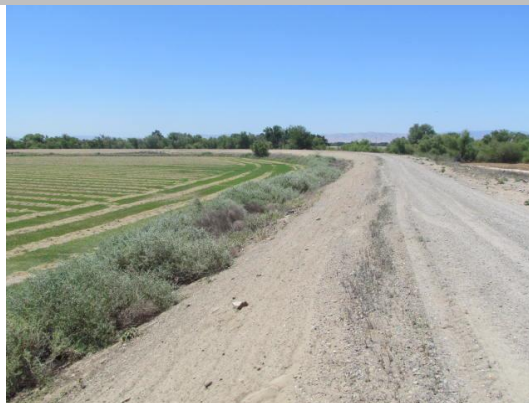
Photo 1 of 1 : SP_2015_RD2063_112_120_20150309_00014.jpg

Looking south at dense vegetation on landside toe.

| Remove the wild growth other than native grasses from the levee slopes. | | | | | |

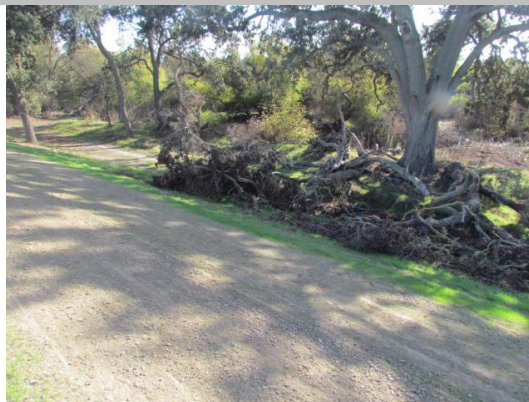
Photo 1 of 1 : SP_2015_RD2063_112_6_20150309_00002.jpg

| Inspector Comments: Fallen tree limbs at waterward toe. | | | | | |

Looking southwest at fallen tree limbs at waterward toe.

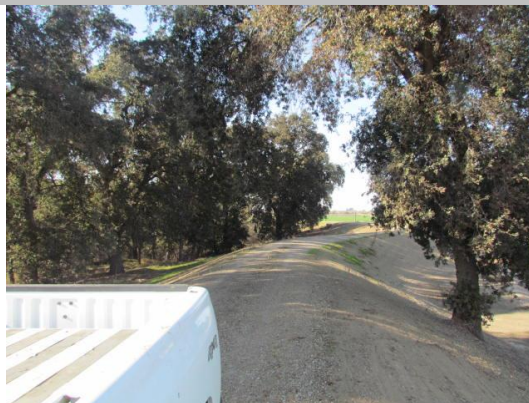
Photo 1 of 1 : SP_2015_RD2063_112_7_20150309_00003.jpg

Looking north at overhanging tree on landward slope.

| Trim trees over roadway to at least 12 feet above ground level. | | | | | |

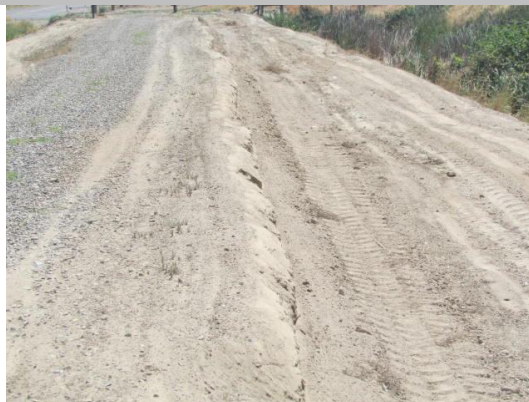
Photo 1 of 1 : SP_2015_RD2063_112_42_20150309_00011.jpg

| Schedule repair of erosion site prior to the next inspection. Inspector Comments: Repair erosion on waterward shoulder. Erosion cause by farm equipment. | | | | | |

Looking north at erosion on waterward shoulder.
